**NEGATIVE WIND PRESSURE TEST ON EXTERIOR SHEATHING  
FOR MANUFACTURED HOUSING APPLICATIONS:  
DOUBLE 2X4 STUD GRADE SPF ON 16-IN. CENTERS SHEATHED ON THE EXTERIOR WITH  
3/8-IN. APA SPAN RATED 24/0 OSB AND  
CLIPSTONE LEDGESTONE BLACK RUNDER FLATS SIDING FOR  
96-IN. TALL EXTERIOR WALLS WIND ZONE III, CORNER**

Prepared for:  
**Environmental StoneWorks  
7306 South Alton Way  
Suite B  
Centennial, CO 80112**

Test Report: ESW071417-2  
Issued: November 9, 2017

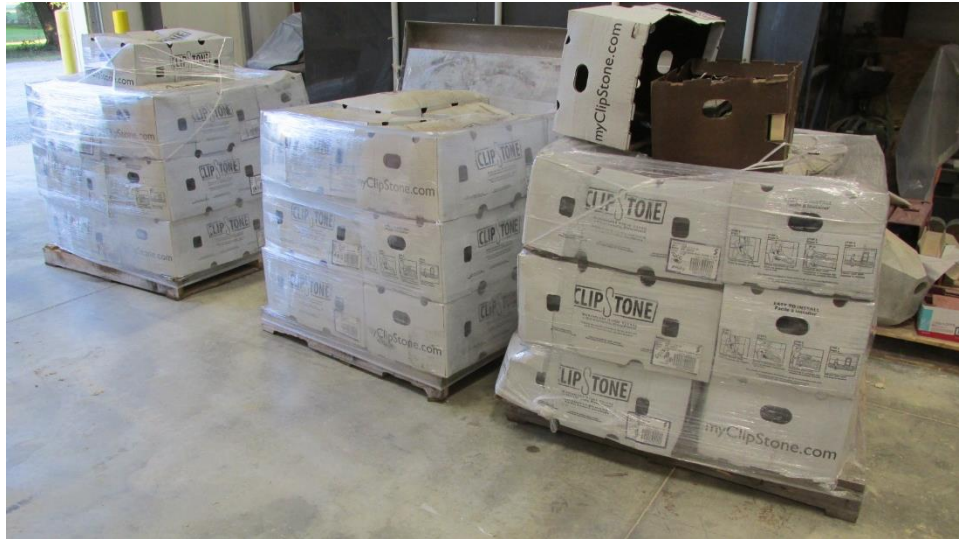
Figure 2: Clipstone Received

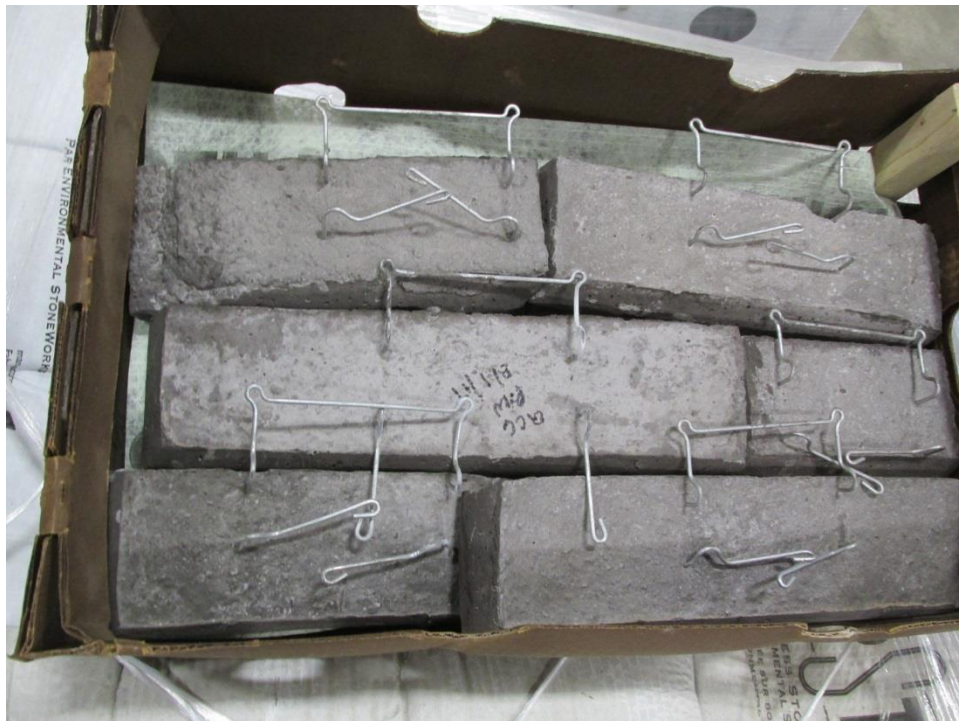
Figure 3: Close-Up View of a Box of ClipStone

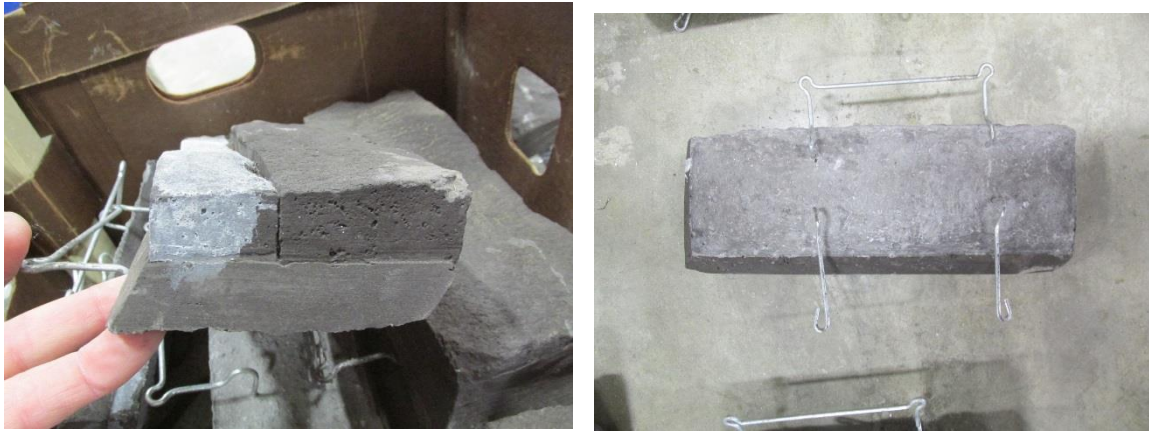
Figure 4: Close-Up Views of ClipStone

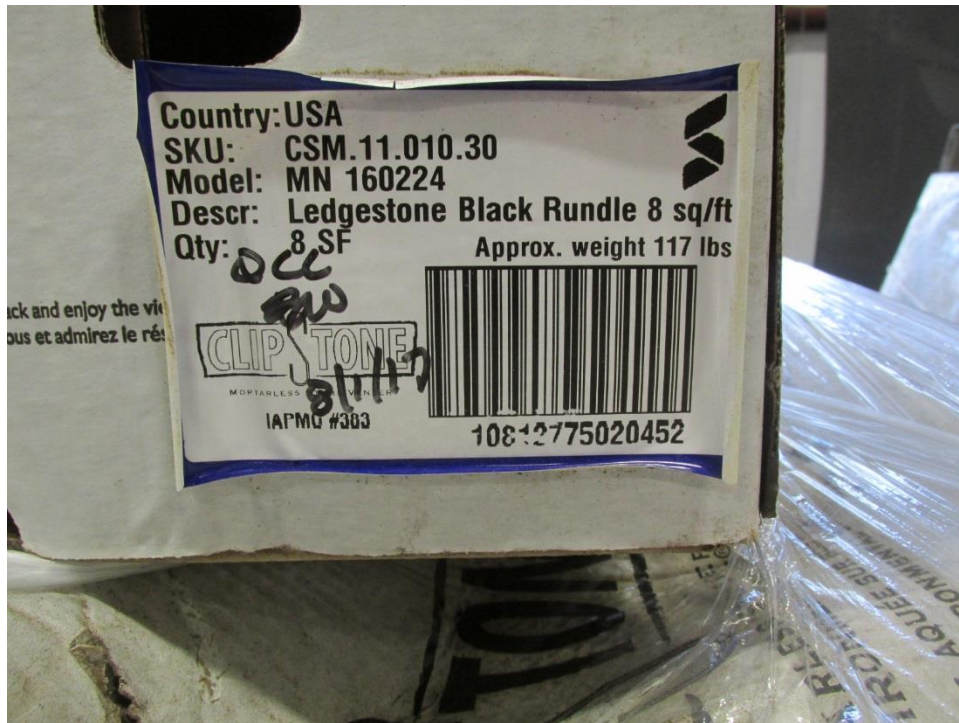
Figure 5: Information on a Box of ClipStone Received

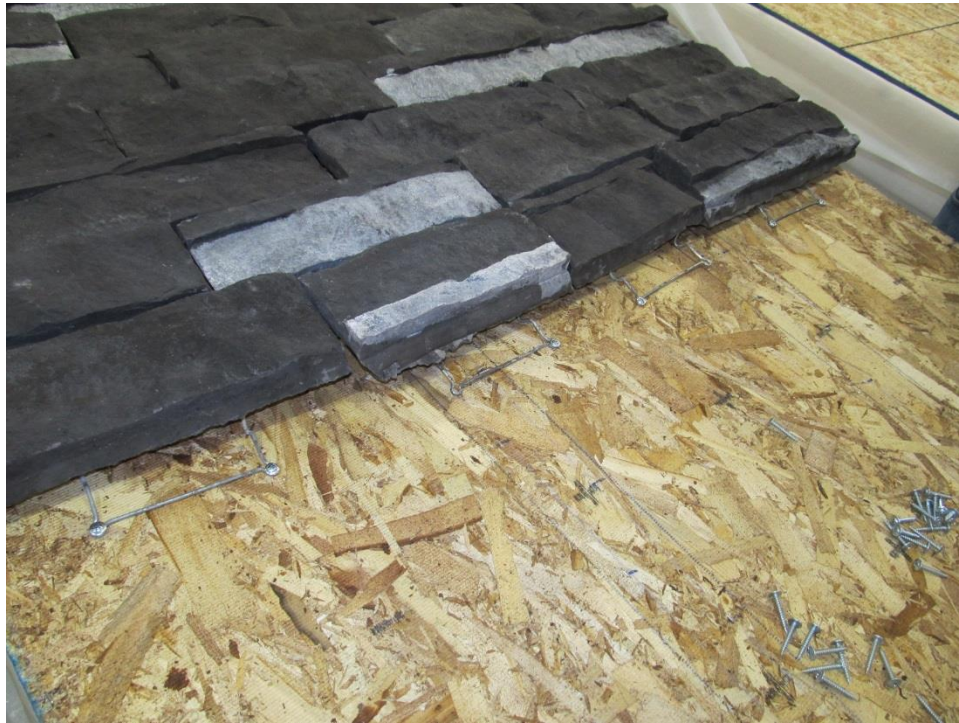
**Figure 6: Attaching ClipStone to a Specimen**

| Connection | Fastener | Quantity or Spacing |
|--|---|--|
| Exterior Siding (Mechanical) | #8 x 1-1/4-in. Buildex Teks Lath Screws, Part #21512,<br>#2 Phillips Head | Through hole in the top of each of the (2) metal hangers the back of each ClipStone piece, except the bottom row of stone which had a fastener in each of the (2) metal hangers above the stone and a fastener in each of the (2) hangers below the stone, fasteners were driven into exterior sheathing only (NOT into studs) |

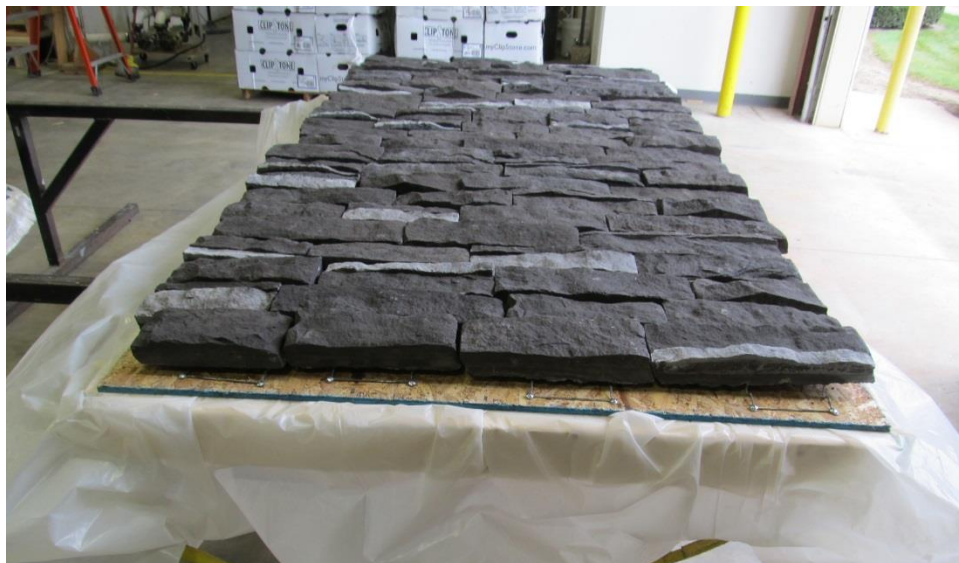
**Figure 7: A Fully Constructed Specimen**

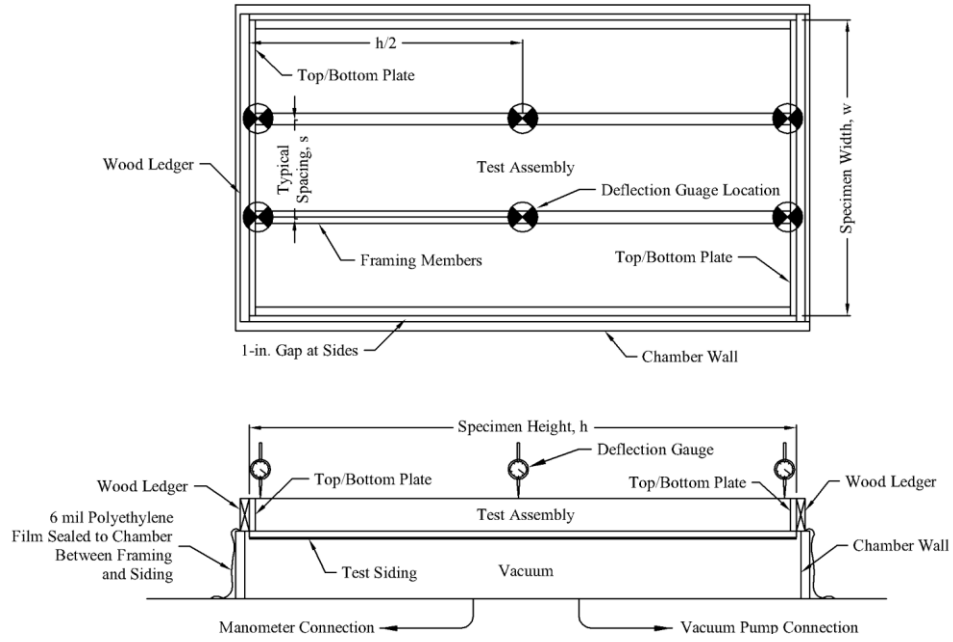
**Figure 8: Test Setup**

The test procedure is based on ASTM E72<sup>2</sup>, Section 11; however, the loading stages were modified to correspond with those required in the ultimate load test procedures found in Section 3280.401(b) of the Federal Manufactured Home Construction and Safety Standards. Accordingly, the test setup consists of a vacuum chamber with an open side slightly larger than the test assembly, as shown in Figure 8. A vacuum pump and manometer connection provide a means to apply and monitor the applied pressure. The samples are placed with the exterior sheathing and siding facing into the vacuum chamber, thereby placing a negative force on the exterior sheathing. The polyethylene

sheeting is pleated to accommodate the specimen deflection and then sealed to the chamber.

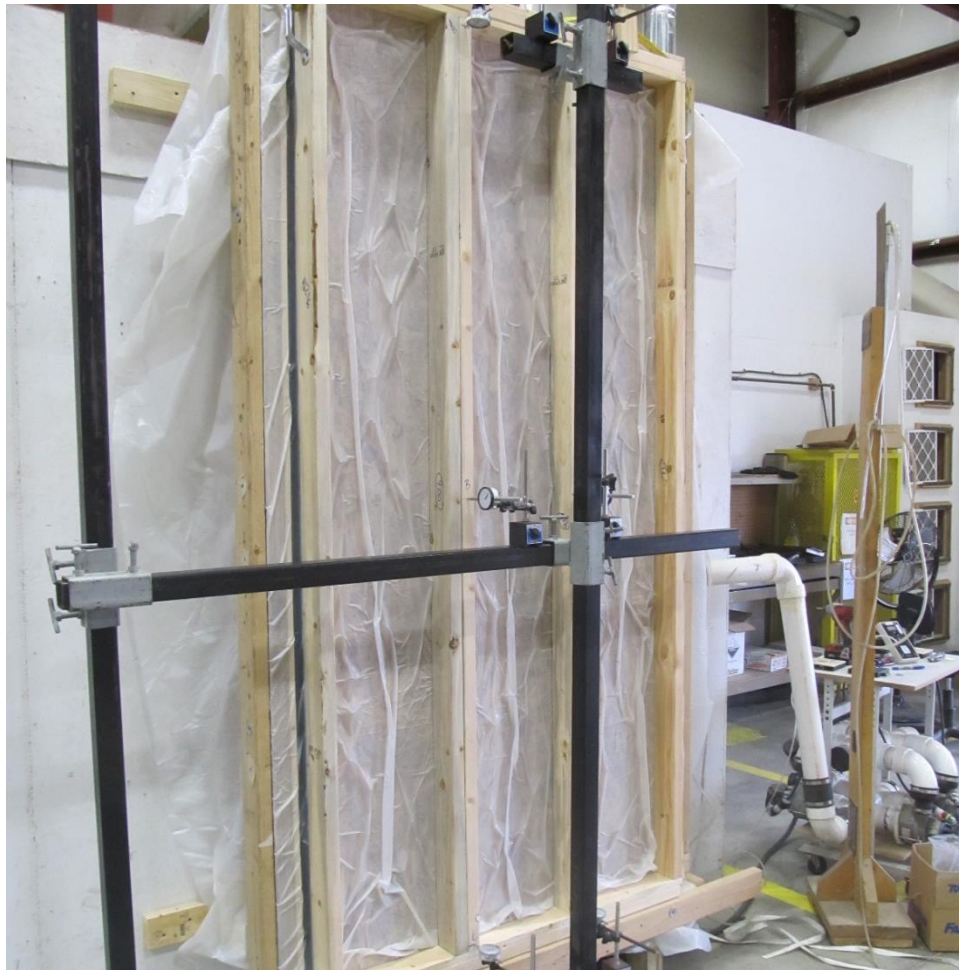
**Figure 9: Test Setup**

Instrumentation consists of a water manometer and dial indicators. The water manometer has a resolution of 0.1 inches of water for pressures up to  $\pm 72.0$  inches of water. Dial indicators, with a resolution of 0.001 in., are positioned along selected studs to take deflection readings at mid-span and at the supports. For specimens with studs spaced at 16 in. centers, the center two studs are gauged, using a total of six dial gauges. For studs spaced at 24 in. centers, only the middle stud is gauged, using a total of three gauges. Figure 9 provides an example of a test setup.

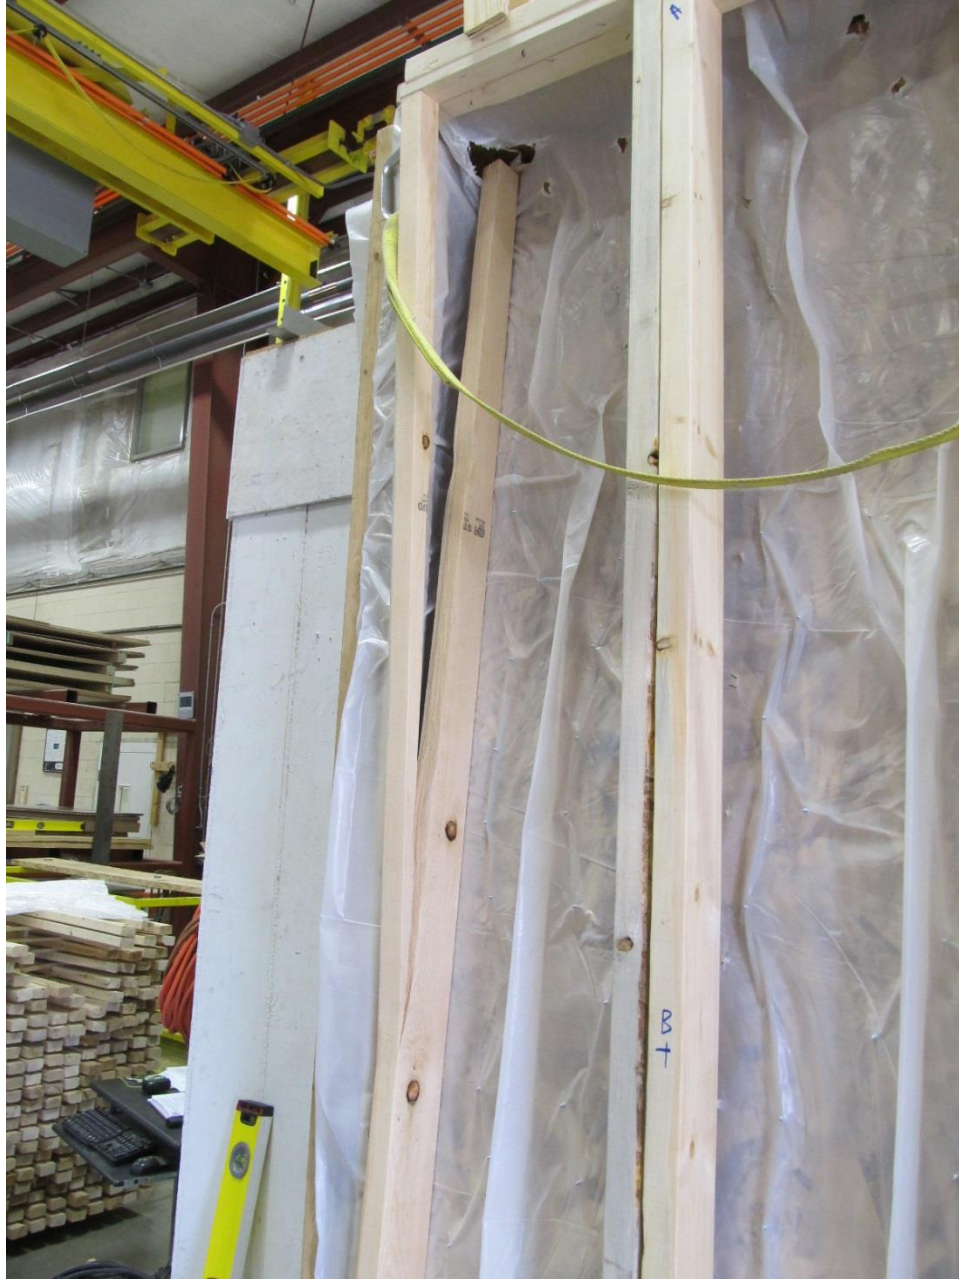
Figure 10: Specimen #94662 after Ultimate

| <b>Specimen</b> | <b>Ultimate Pressure (psf)</b> | <b>Service Load Deflection (in.)</b> | <b>Failure Mode at Ultimate</b> |
|---|---|---|--|
| 94662 | 235 | 0.322 | <i>Left outer stud failure leading to bottom plate failure and exterior sheathing to framing fastener withdrawal</i> |

**Failure Mode:** *Left outer stud failure, leading to bottom plate failure, followed by sheathing to framing fastener withdraw*

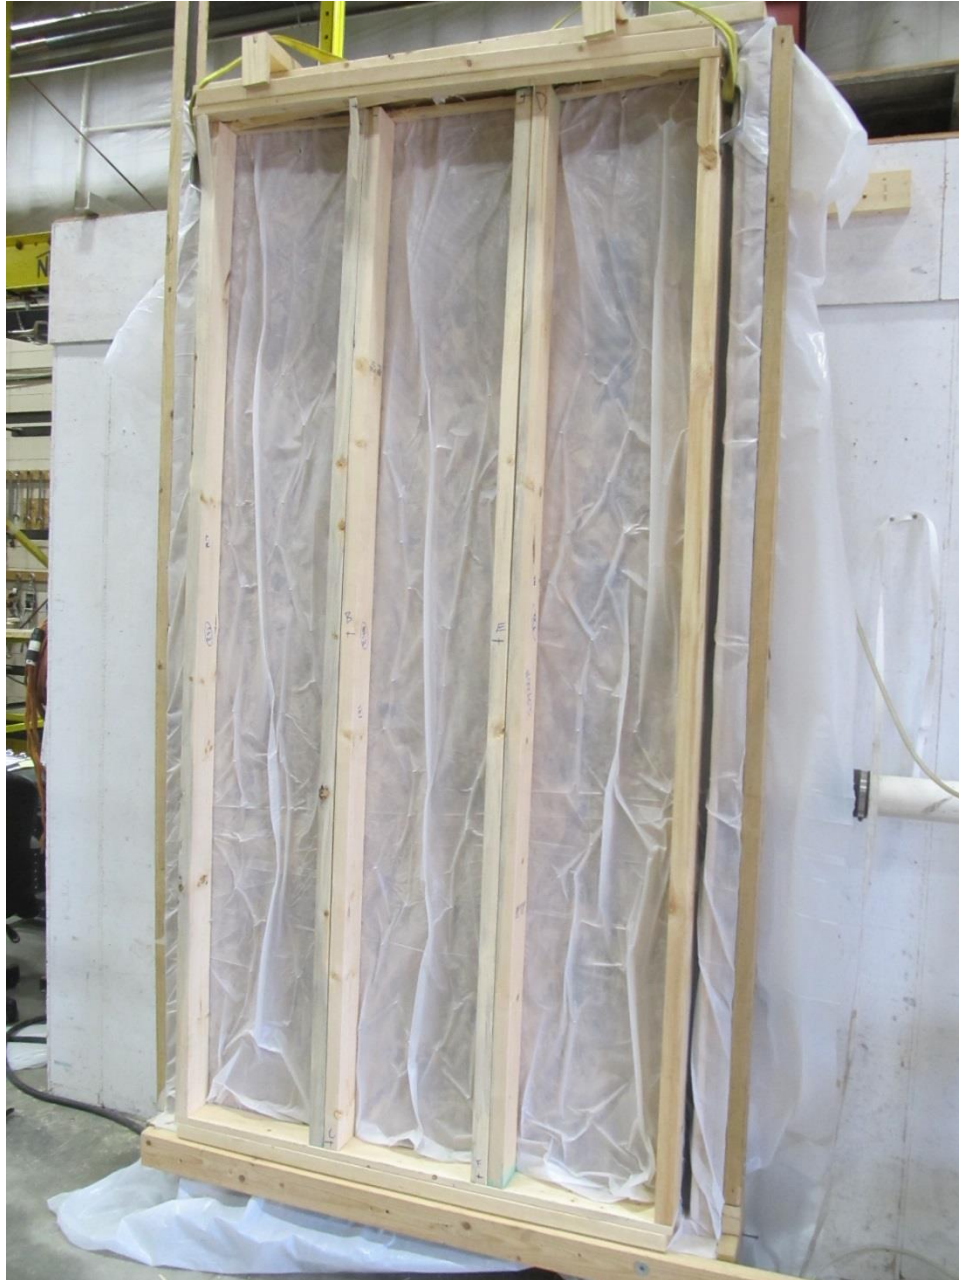
**Figure 11: Specimen #94663 after Ultimate**

| <b>Specimen</b> | <b>Ultimate Pressure (psf)</b> | <b>Service Load Deflection (in.)</b> | <b>Failure Mode at Ultimate</b> |
|---|---|---|--|
| 94663 | 213 | 0.349 | <i>Top plate failure</i> |

**Net LL Deflection: 0.349-in. at 58 psf**  
**Ultimate Uniform Load: 213 psf**  
**Failure Mode: Failure of the top plate.**
